United States Steel Corporation
 Law Department
 600 Grant Street
 Pittsburgh, PA 15219-2800
 Tel: 412.433.2919
 Fax: 412.433.2964
 E-mail: dwhacker@uss.com

May 27, 2009

On or about April 23, 2009, United States Steel Corporation (U. S. Steel) received a Clean Air Act Section 114 Request for Information regarding its Gary Works. As discussed with Sabrina Argentieri of U. S. EPA on May 21, 2009, U. S. EPA agreed to accept a response submitted on or before May 27, 2009, as timely.

U. S. EPA Request No. 1: Doors – "Provide a detailed explanation of the actions taken to date by U. S. Steel to prevent the reoccurrence of coke oven door leaks at Batteries 2, 5 and 7."

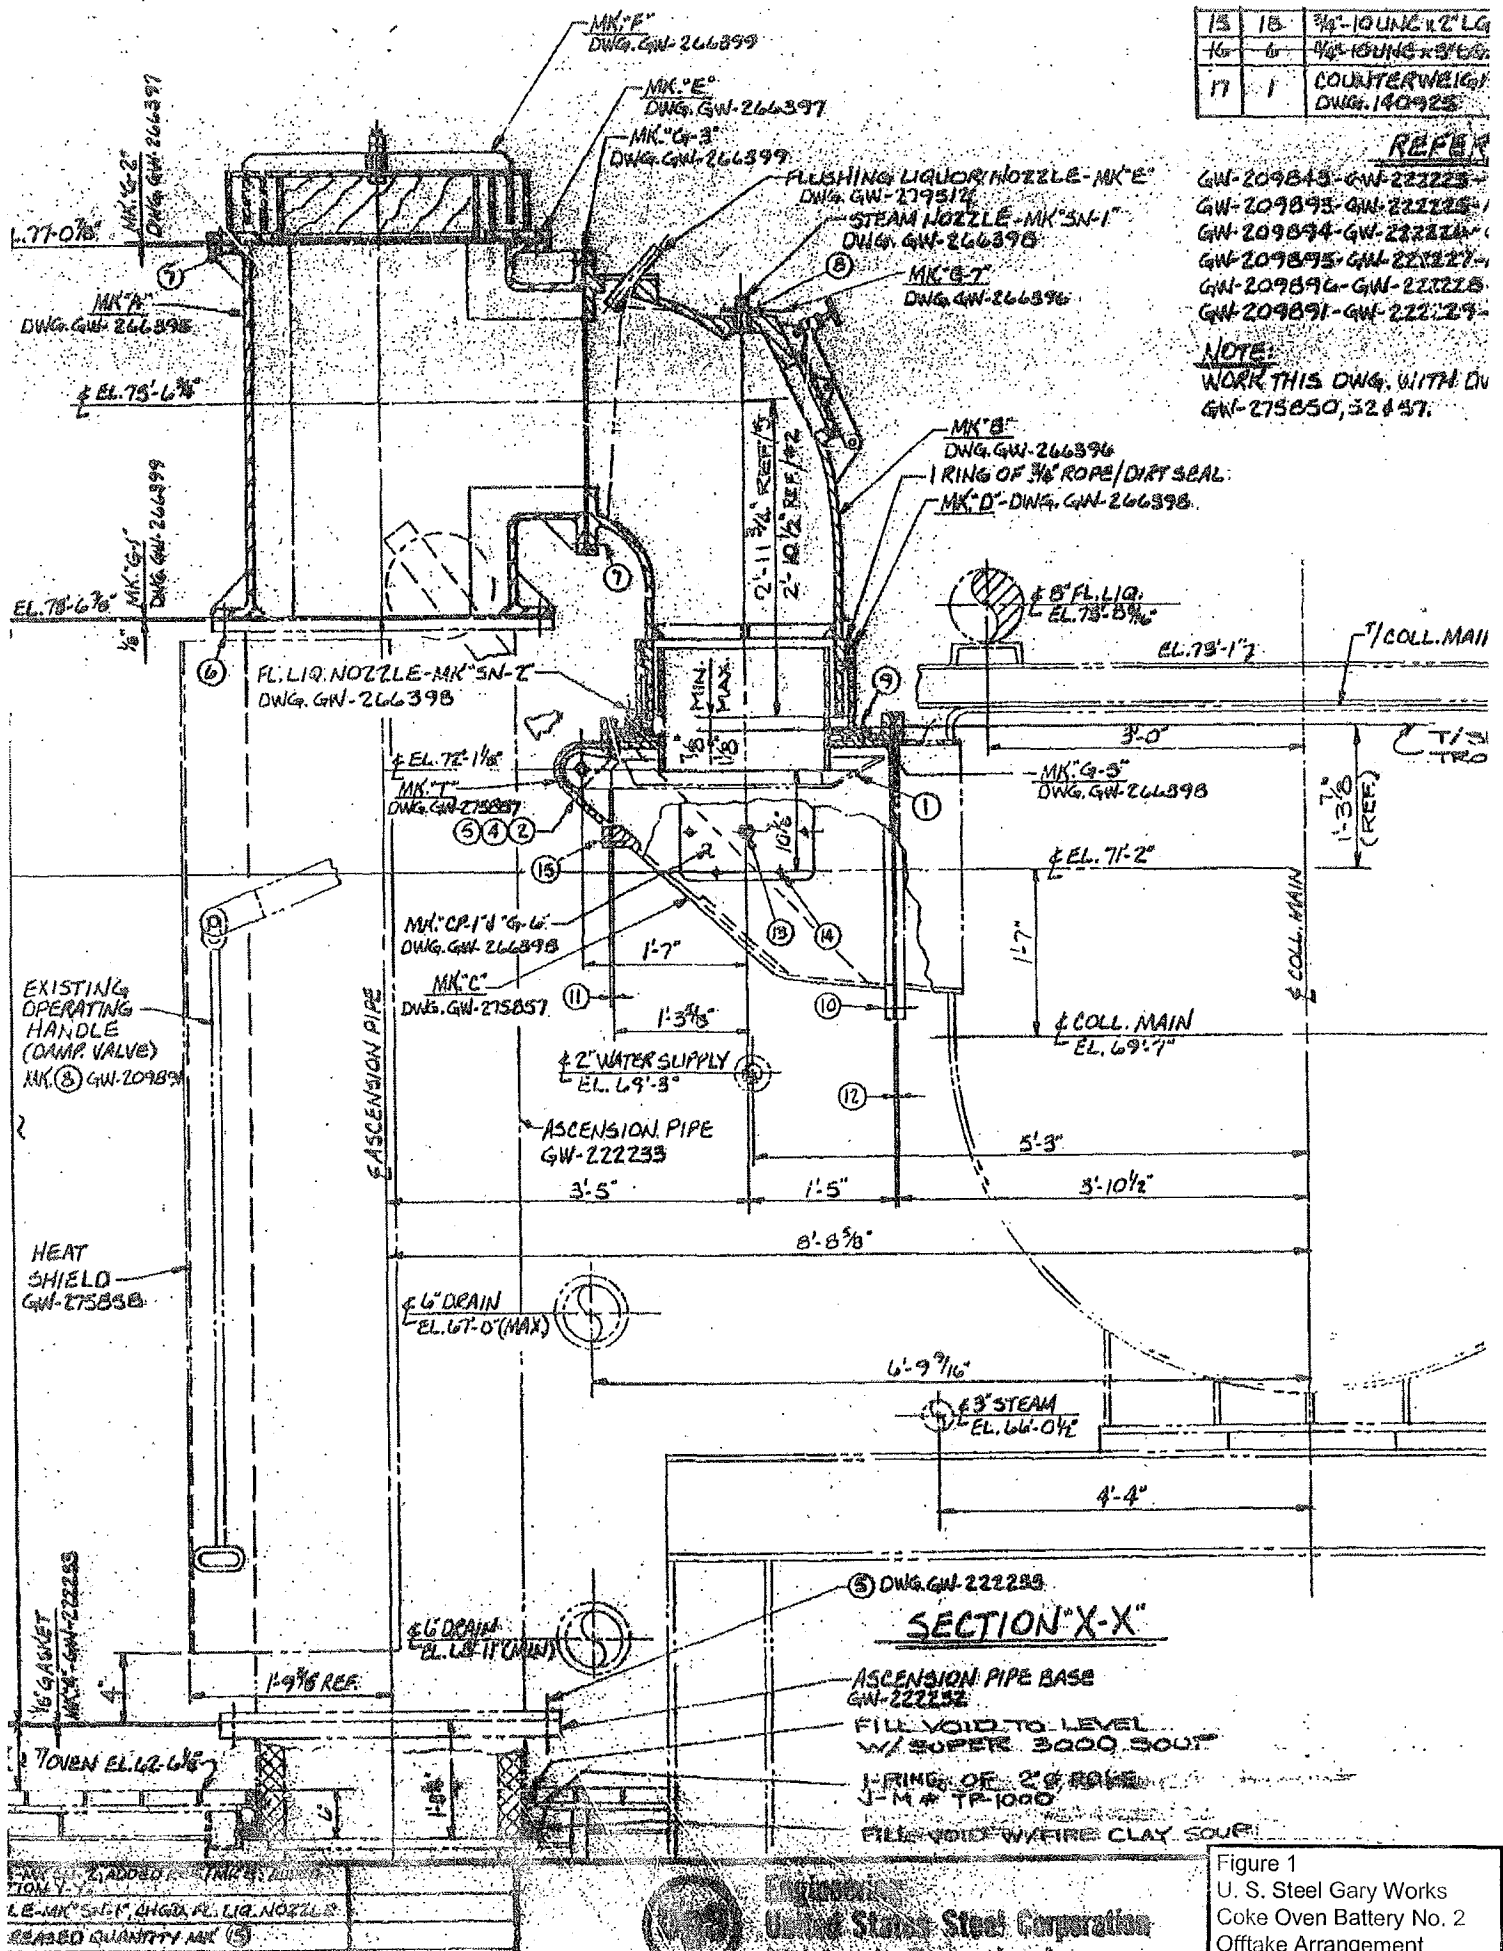
To respond to U. S. EPA's request for an "engineering study of the offtake piping program for each battery," U. S. Steel is attaching Figures 1 and 2 which are schematics of offtake arrangements for Battery 2, and Batteries 5 and 7, respectively, noting that the offtake arrangements on Batteries 5 and 7 are essentially the same.
